DISASTER AT WEEDON

Earlier in this issue, we discussed the tasks involved in keeping the steam locomotive functioning efficiently and safely. Exactly 35 years ago, a major disaster emphasised just how vital and demanding this work was. For a few autumn days, a hitherto quiet field in rural Northants provided a focus for all the skills the steam railway could muster. LEWIS READE recounts what happened

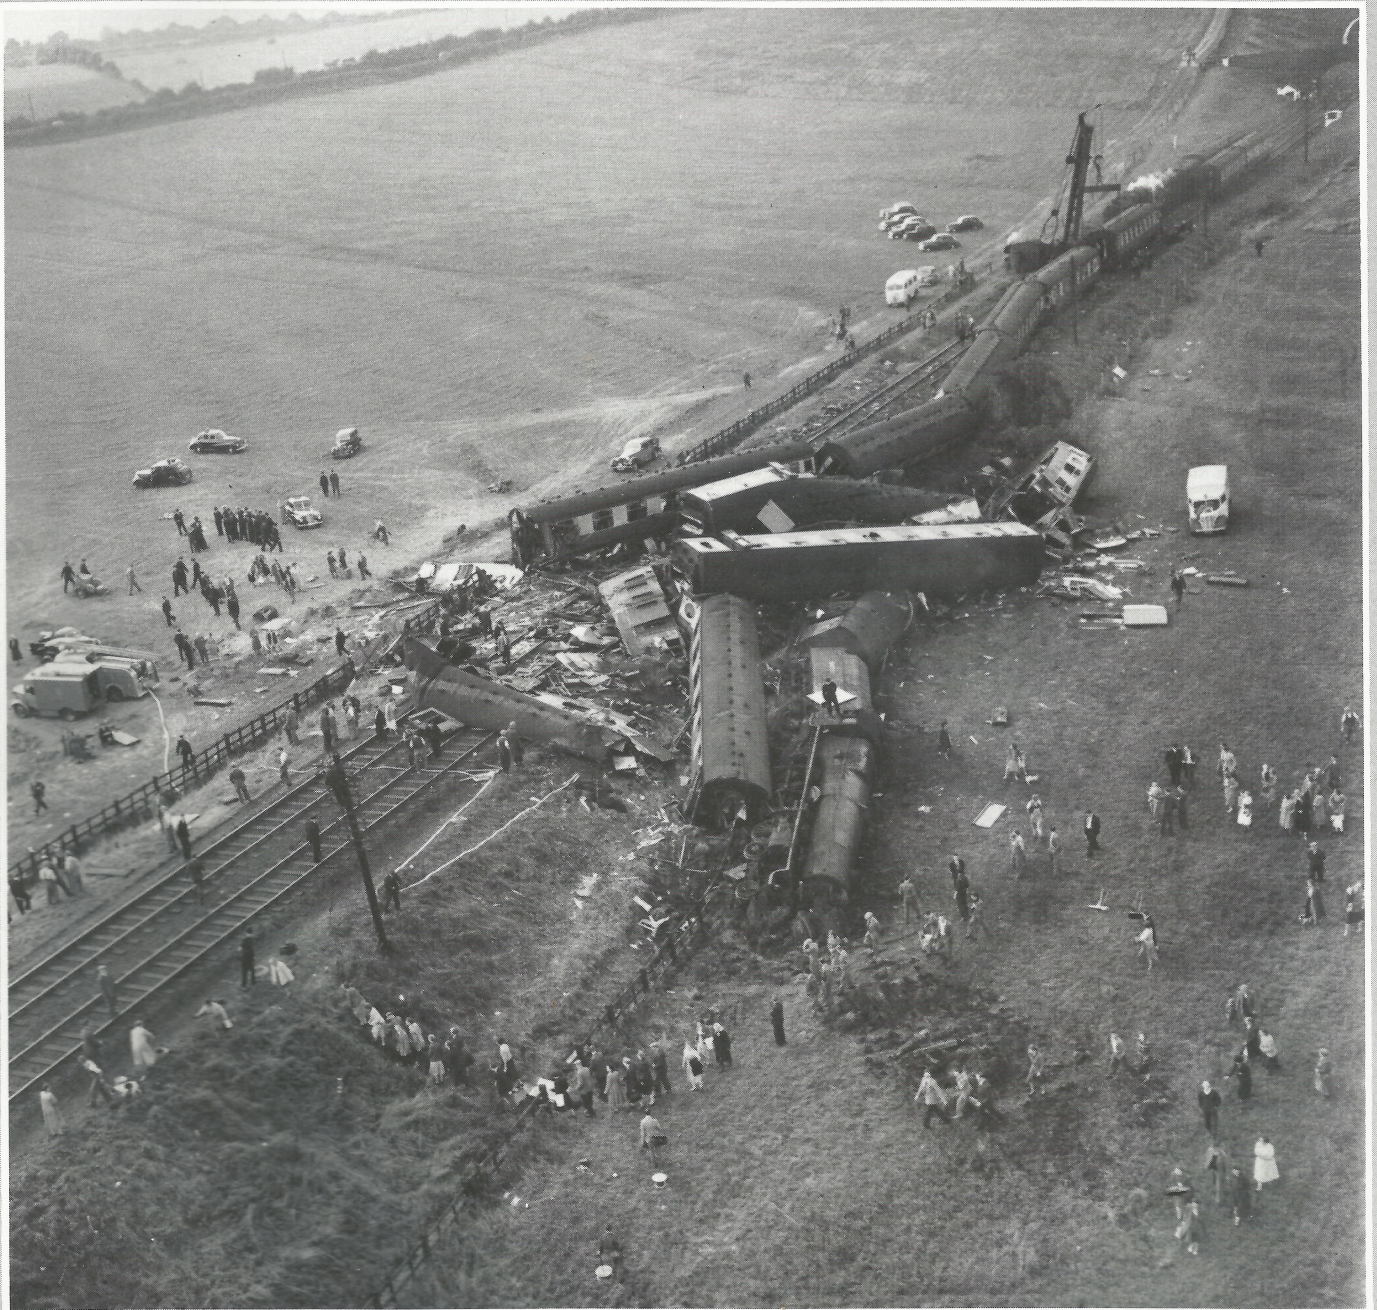
The grim scene at Weedon on 21st September 1951, approximately two hours after the accident occurred. Visible, top right, is bridge No.231 with the portal of Stowe Hill Tunnel just discernible beyond. This aerial view gives a very clear impression of the destruction of the train and the dispersment of the coaches, each of which can be identified from the accompanying text.

Only two ambulances are seen in attendance, all the injured having been transported from the scene by 12.15 pm. In the foreground the uninjured passengers are mounting the embankment; a police constable is directing them up the line to Heyford signal box where they will board the halted down 'Royal Scot' which will at 1.45 work back to Blisworth.

The breakdown crane is from Rugby. It was supplemented by those from Willesden at 4.00 pm and Bletchley at 5.30 pm. Note the fire officer standing on the cab side sheet of the engine, presumably checking that the fire is safely out; the hose snaking across the tracks no doubt having been used for this purpose. A linesman is already working on the telephone wires brought down by the accident and note the elegant Bentley standing in the field above the wrecked coaches, a local doctor perhaps? Photo: The Press Association
