DISASTER AT WEEDON

Earlier in this issue, we discussed the tasks involved in keeping the steam locomotive functioning efficiently and safely. Exactly 35 years ago, a major disaster emphasised just how vital and demanding this work was. For a few autumn days, a hitherto quiet field in rural Northants provided a focus for all the skills the steam railway could muster. LEWIS READE recounts what happened

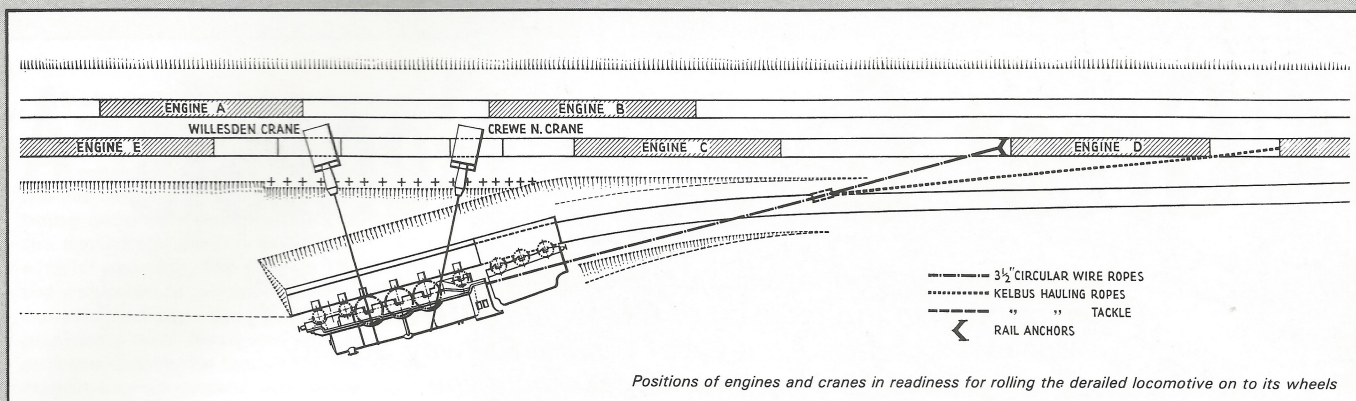
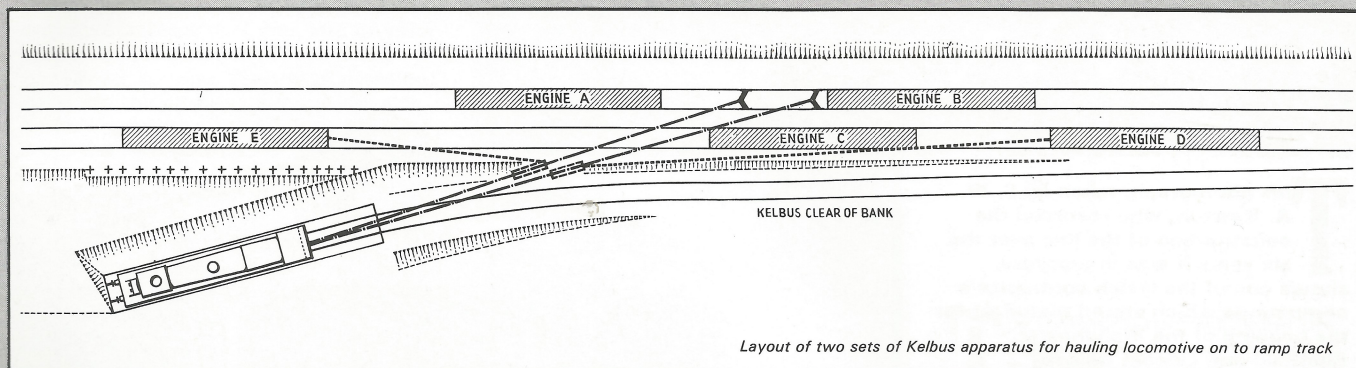
Attention turned to the engine. As early as 24th September, excavation in the field at Weedon had allowed the Ministry of Transport Inspecting Officer, Lt. Col. G. R. S. Wilson, to make a preliminary examination of the engine's bogie wheels. Light indentations and deeper bruising immediately showed where the leading wheels had come into violent and repeated contact with, respectively, the elastic spikes of the flat bottom rail and the chairs of the

bullhead rail. These marks corresponded closely with the damage to the track between the points of initial and final derailment. No other wheels were damaged and it was thus established at a very early stage that only the leading bogie wheels had initially become derailed, and examination of the track gave clear evidence that this was subsequently the direct cause of the total derailment. But why had the bogie wheels derailed in the first instance?

The answer could not be found until the bogie assembly had been completely dismantled at Crewe Works. Generally, it was found to be in good condition: all tyres and flanges had good profiles, there was no excessive side play between the axles and their boxes and the boxes and the horns, and wear on the central pivot was light. The coil springs were in satisfactory condition as were all journals and bearings, with no evidence of overheating. It was only when attention was turned to the bogie's leading axle boxes that the cause of the tragedy at Weedon became apparent. Both boxes were much too tight in the fore and aft direction and unusually bright patches on all four white metal faces provided clear evidence of excessive friction. Conversely, the two trailing axle boxes of the bogie showed very slack fit, with more than 3/32" fore and aft play on the right hand side.

"There is no doubt whatsoever that the derailment of the leading wheels of the engine bogie was brought about by the lack of freedom on the axlebox in the horns." The reader has already seen how this defect led, inexorably, to a major disaster.
